DEVELOPMENT OF A PAVEMENT LIFE CYCLE ASSESSMENT TOOL FOR AIRFIELD
REHABILITATION STRATEGIES

THESIS

Submitted in partial fulfillment of the requirements
for the degree of Master of Science in Civil Engineering
in the Graduate College of the
University of Illinois at Urbana-Champaign, 2015

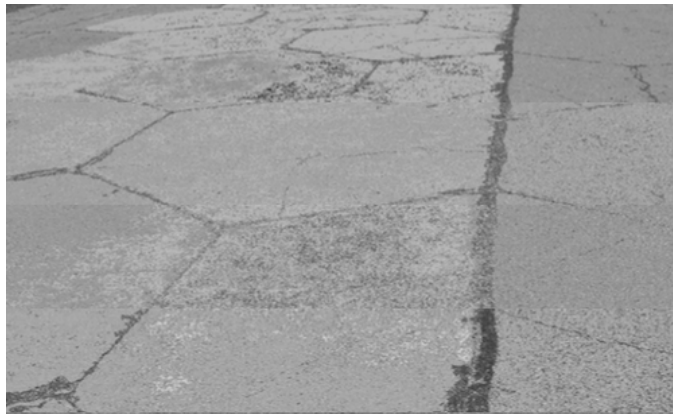
Figure 15 - Soviet Precast Hexagonal Concrete Slabs (approximately WWII Era)
(Sapozhnikov & Rollings, 2007)

The former Soviet Union placed its first precast concrete airfield pavements in 1931-1932 using a hexagonal design (4 foot long sides and depth ranging from 4 – 5.5 inches). Due to increased loads, these sizes increased and in the 1950's traditional rectangle slabs became available. Figure 15 below, shows the hexagonal precast slabs that were still in use in 2007. Figure 16 shows the rectangular slab with the welding ties (Sapozhnikov & Rollings, 2007) . The Japanese (as early as 1970's) have used precast slab panels in various applications, including airports, highways, tunnel pavements, and high-speed slab track. During the commencement of conflict in Afghanistan, US military encountered precast paving by the former Soviet Union (placed in 1980's) on several airfields (Tayabji, Buch, & Kohler, 2008).

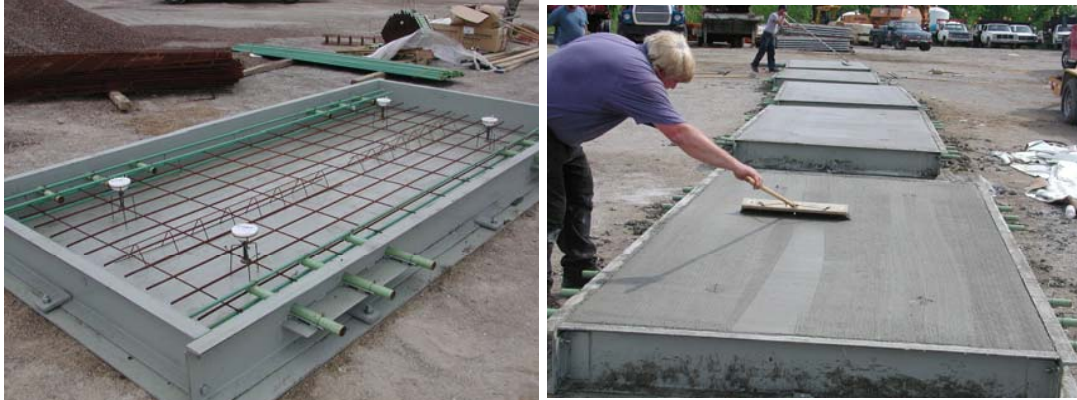
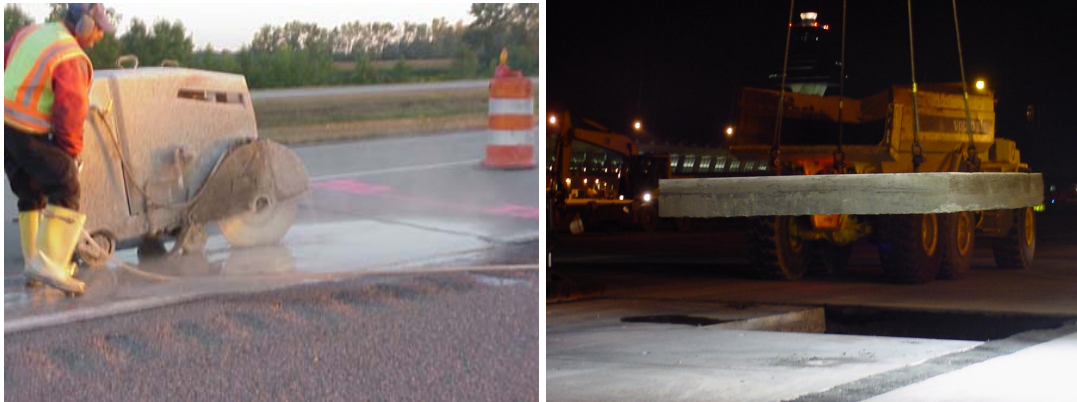
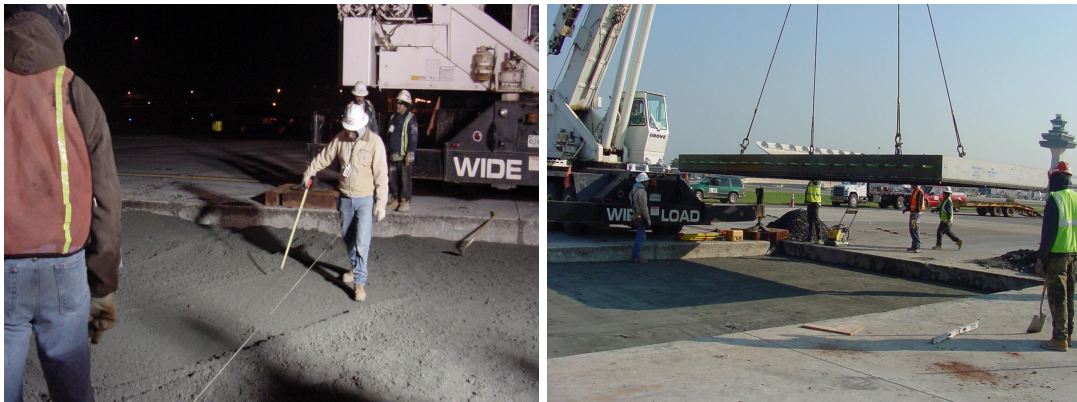
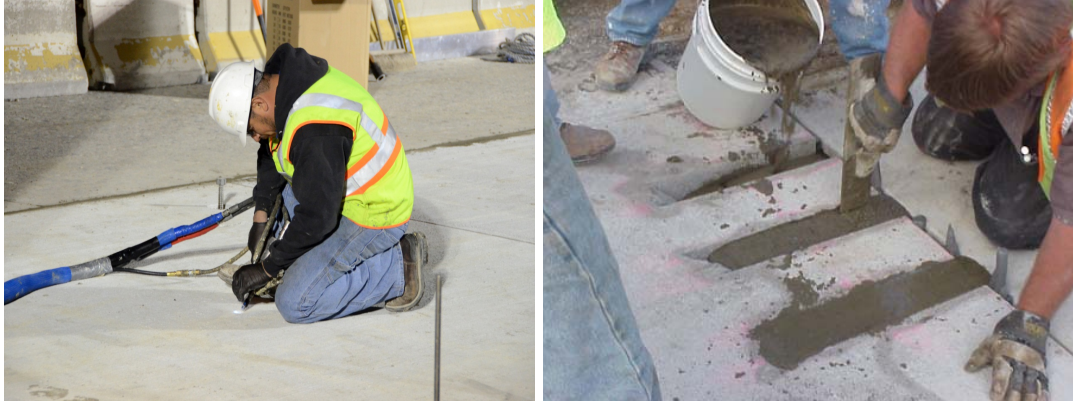
(a) Casting and finishing slabs
 Figure 18 - Precast Generalized Methods (a-d)

(b) Sawcut slab/dowels and remove existing slabs

(c) Base preparation and new slab placement

(d) Base grout injection and dowel grouting

Multiple PPS have been developed to enhance the rapid pavement repair techniques and efficiencies. A short description and discussion is below for each. This provides engineers with the opportunity to select the method/combination of methods, which will best suit their needs. PPS have similar construction methods; primarily, slab casting, existing slab removal, base preparation, placing precast slab, setting/grouting of slab and other finishing activities such as diamond grinding or marking. These methods are shown below in Figure 18. Individual systems are discussed after in further detail.

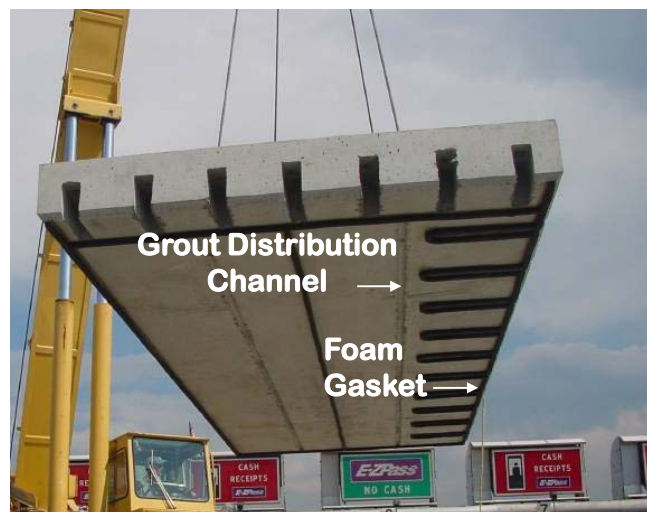
Figure 20 - Super-Slab Precast Panel (grout channels, foam gasket and dove-tail dowel slots)
(Smith P. J., 2008)

The second difference is grout distribution channels on the bottom side of the slab as seen below in Figure 20. This helps uniform distribution of the grout to ensure full contact is achieved between the slab and the base material. The third difference is the foam gasket attached to the underside of the slab to prevent grout material from entering both the dowel slots and joints. Grout in either of these to locations will compromise the performance life of the pavement. The fourth difference is the ability to fabricate warped slabs (three-dimensional) to meet the needs of superelevation transitions, curves, ramps, etc. (Smith P. J., 2008). A rendering of the warped slabs is seen in Figure 21. Multiple projects across the US have successfully implemented this slab type.

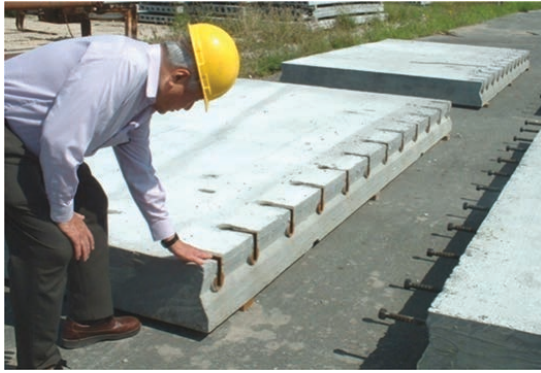
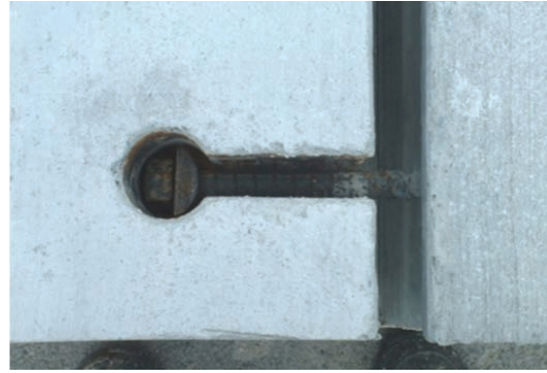
Figure 23 - Kwik Slab Precast Slabs and Kwik Joint Steel Couplers
(Kwik Slab, 2006; Tayabji, Buch, & Kohler, 2008)

The Kwik Slab system was a proprietary system used on roadways since 2005 that simulates jointed reinforced concrete pavement (JRC) sections. Use was limited to a small number of projects in Hawaii (Tayabji, Buch, & Kohler, 2008). It is often cited in precast papers as but is no longer produced. It used Kwik Joint Steel Couplers, in the reinforced slab, to quickly connect slabs together as seen below in Figure 23 (Kwik Slab, 2006). This enabled continuity of load throughout all sections. Due to this continuous connection the number of consecutive panels is limited. Kwik connectors were discontinued and replaced with a new connector system called AE Connectors.

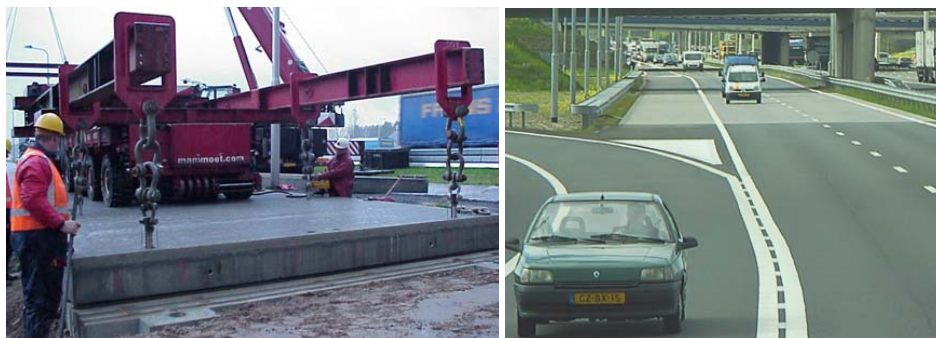
Figure 28 - ModieSlab System in the Netherlands

ModieSlab is a proprietary system designed in the Netherlands in 2001 as part of the Roads to the Future program. The roadway design was for 100 years. The Netherlands has many areas of weak soil and in order to overcome some this with the ModieSlab systems was designed as a bridge type structure. Precast pile foundations were driven into the soil and capped with precast beams. The pavement slabs were then placed on the precast beams. The slabs consist of a reinforced base concrete (12.25 inches) and topped with a two layer (2.75 in) porous concrete. The top surface layer is fine-grained porous mix to reduce tire noise/surface water and the second layer is a coarser-grained mix to remove water quickly to the edges. Advancements were made to include a load transfer system for a slab-on-grade approach where soils were stronger.

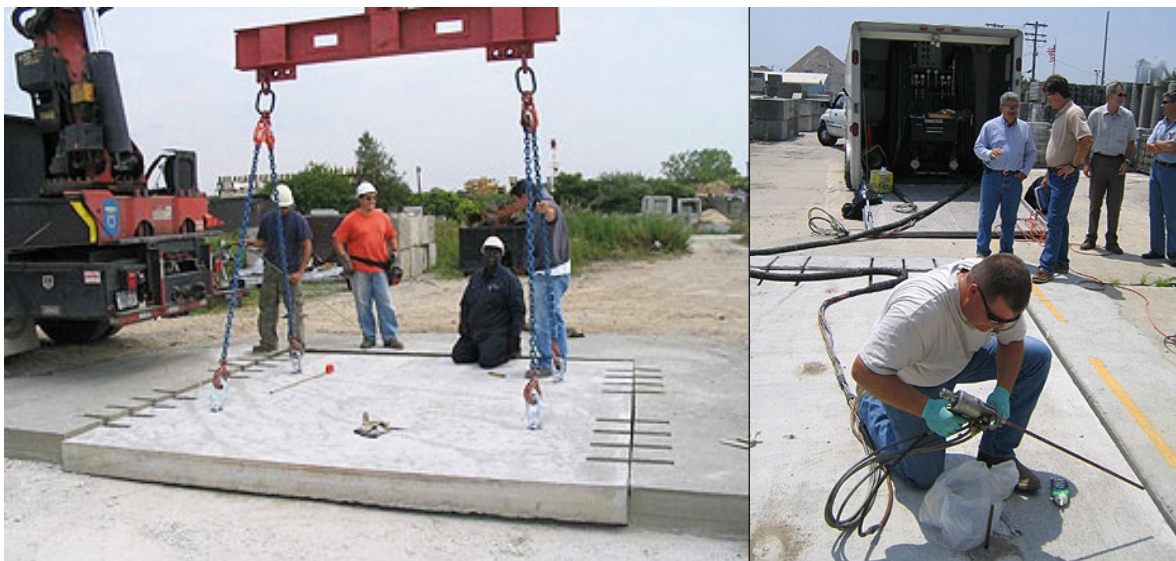
Figure 29 - Roman Road System Installation (left) and URETEK Underslab Grouting (right)

Roman Stone Construction Company developed the proprietary Roman Road System in 2009. This slab is cast whole (no dowel slots or dowels) and placed on a minimally prepared subgrade. Typically the slab is one inch less deep than the existing pavement. The one-inch difference is made up through the use of URETEK's high-density polyurethane foam, which raises and levels the slab while ensuring complete contact between the slab and the subgrade. After the foam is injected, dowel slots are cut into the precast and existing slabs. The dowel bars are then placed and subsequently grouted (Roman Stone Construction Company, 2014).

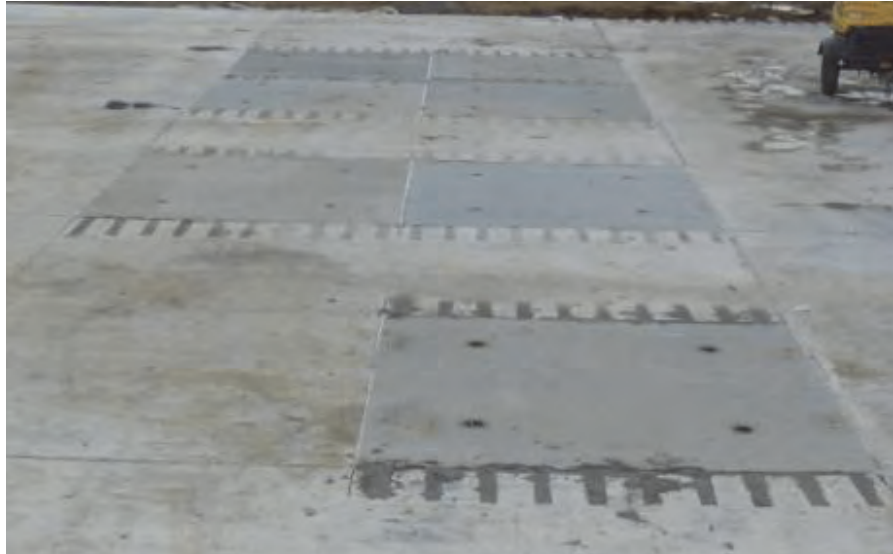
Figure 33 - U.S. Army ERDC Completed Precast Panel Repair

Full scale testing was performed for three different repair types. These types consisted of a single panel, double panel and quad panel repair. This simulated a quarter (P1), half (P2/P3) and full (P4/P5/P6/7) panel replacement as seen in Figure 32. The test section was design using Pavement-Transportation Computer Assisted Structural Engineering (PCASE) software. Critical inputs include design life of 50,000 passes of a C-17, six inch aggregate base, subgrade k-value of 150 lbs/in³ and a flexural strength of 650 psi. Based on the software recommendations a 20-foot panel by 14 inches deep was selected with 20 inch long by one inch diameter dowels, spaced at 15 inches on center. The repair panels were 10 feet square by 11 inches deep. Three inches of aggregate base was added to account for the three-inch difference during the repair. The test section with completed repairs is seen in Figure 33.

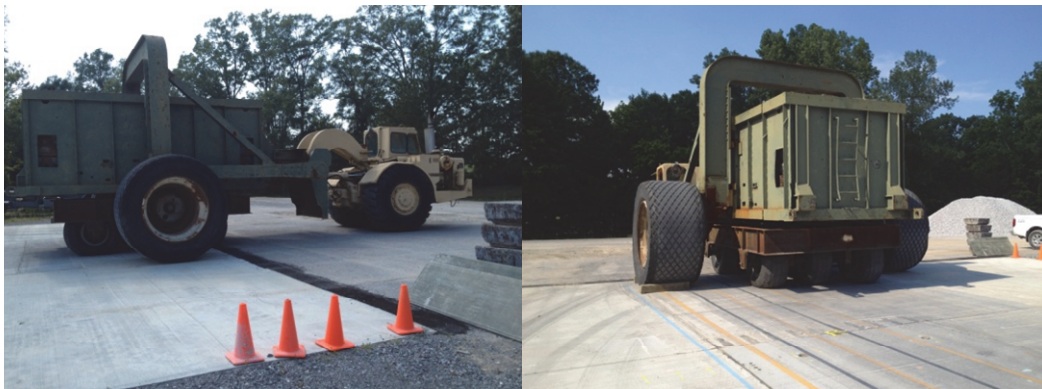
Figure 34 - C-17 Load Cart

After repairs were completed the sections were loaded with a C-17 load cart, which simulates one belly gear set. The load cart simulated the max weight of a C-17 (586,000 lbs), which equates to a test weight of 269,560 lbs. Individual wheel loads were approximately 44,930 lbs with tire pressures of 138 – 144 psi. The pavement was trafficked until 10,000 passes or pavement failure. The wheel paths were performed using a normal distribution. In addition to strain gauges and pressure cells, faulting and heavy-weight deflectometer (HWD) testing was performed throughout testing.

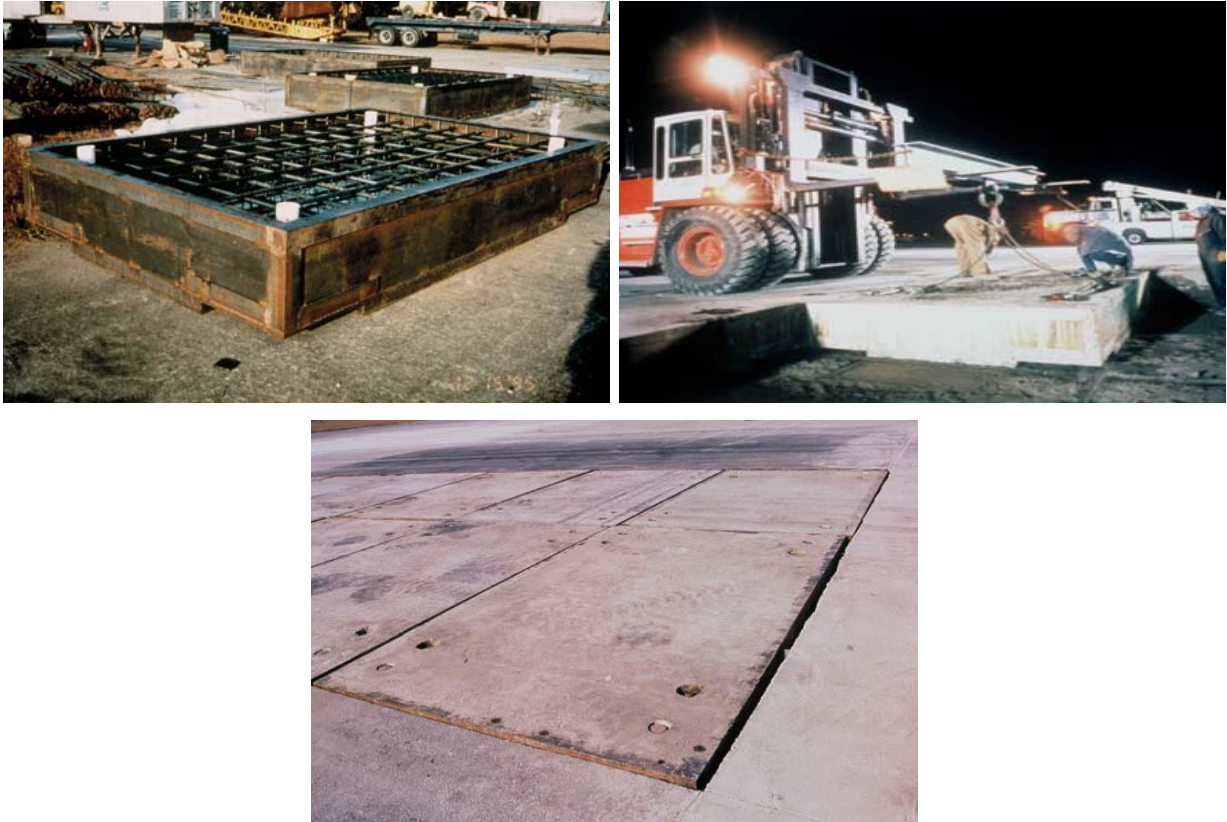
Figure 40 – Temporary PCP Used at Savannah-Hilton Head International Airport
(Peshkin, Bruinsma, Wade, & Delatte, 2006)

Precast pavements in airports have been used in Europe, Japan and the United States since the 1940s (Rollings & Cho, 1981). In the past 20 years PCPs test sections have been demonstrated at four airport locations; Calgary International, Dulles International, La Guardia International and Lambert-St. Louis International. Further material is presented later on each specific airport. Other airports have used PCPs for temporary surfaces during construction activities (Figure 40). These include Seattle-Tacoma International, Charleston International and Savannah/Hilton Head International airports. PCPs were used to increase production by allowing a larger section to be removed in a night while opening to traffic the following day. The next night, the PCPs were removed and the designated PCC mix was poured. It also allowed for emergency measures if equipment broke down or an early opening of the runway was required (Peshkin, Bruinsma, Wade, & Delatte, 2006).

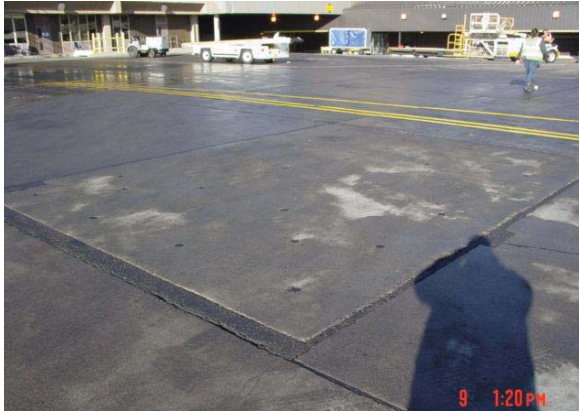
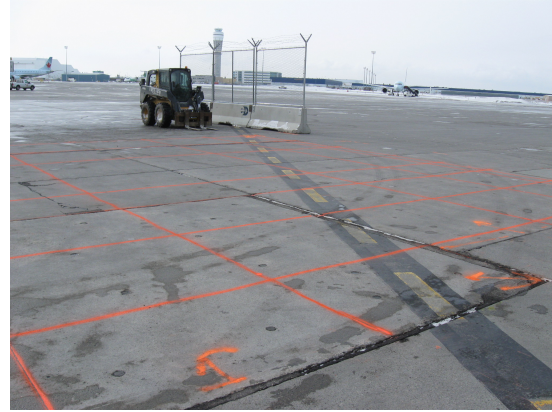
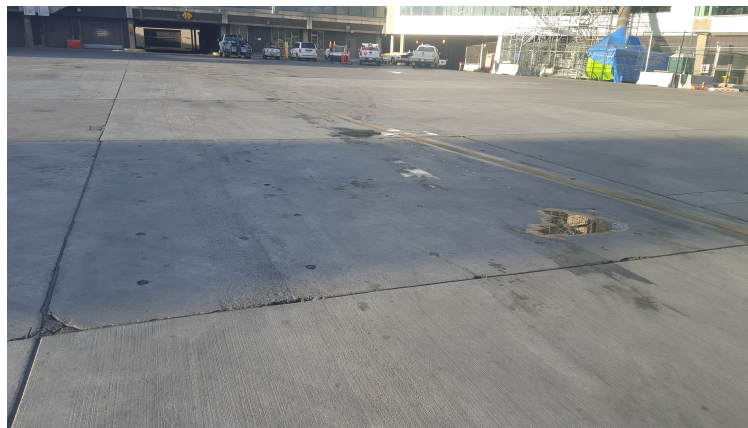
a) 2007 condition (12-15 yrs)

b) 2013 condition (18-21 yrs)

c) 2015 condition of other PCP in same area (20-22 yrs)

Figure 42 – Precast Slab Replacement at Calgary International Airport
(Lightfoot, 2007; Botero, 2015)

Figure 42, taken in 2007 shows one of these panels. In 2010, Mr. Jim Lightfoot reported that 10 of 13 panes were still performing well with no evidence of cracking. The panel shown in Figure 42a, was removed in 2013 during annual maintenance due to cracking in the surrounding panels. Figure 42b, was the panels condition prior to removal. Figure 42c, shows the current condition of a panel installed in the same time frame. It is in good condition for over 20 years with a minor corner spall (Botero, 2015).

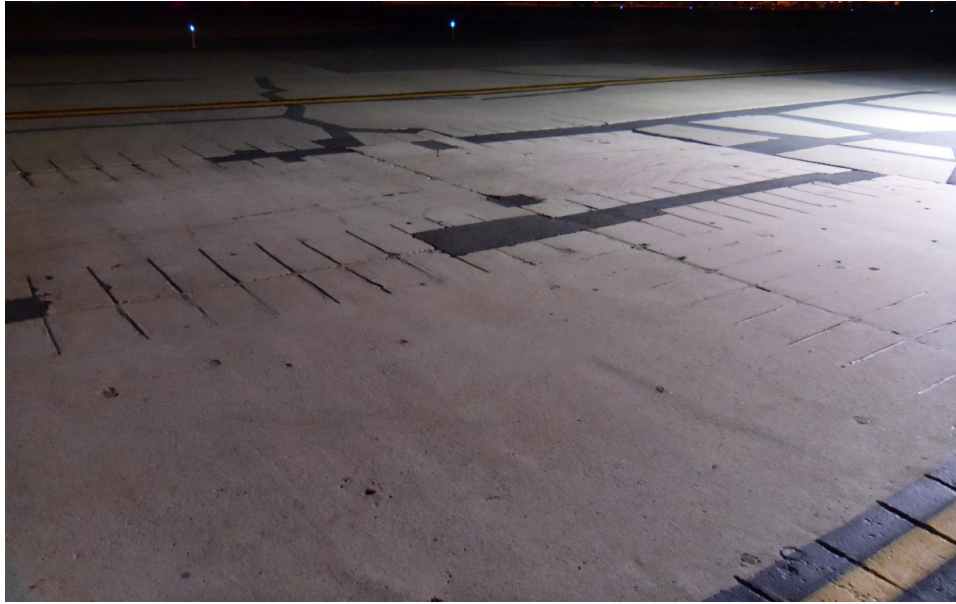
Figure 44 - Dulles Taxilane Bravo Stitch-in-Time Method Condition in 2013
(Thuma, 2013)

durability. However, the joints that were locked together with the stitches have evidence of failure based on the asphalt patching repairs seen along several joints.

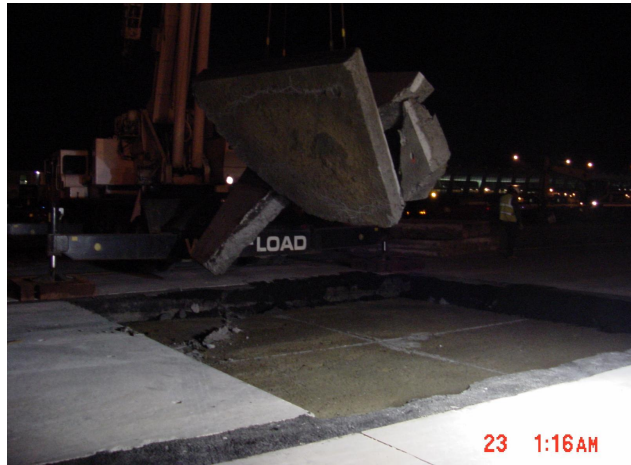
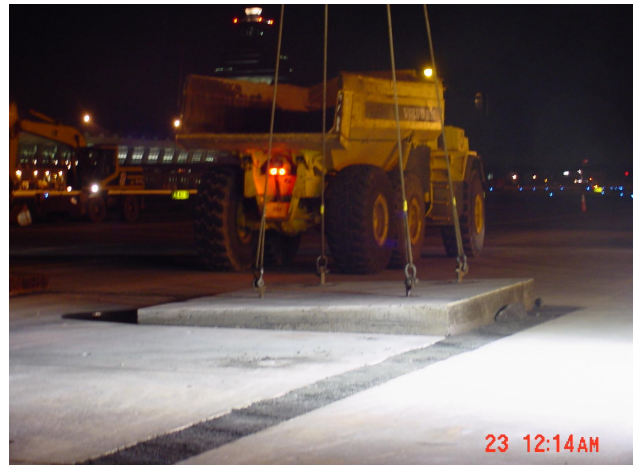
Figure 45 - Dulles Slab Demolition
(Fischer, 2002)

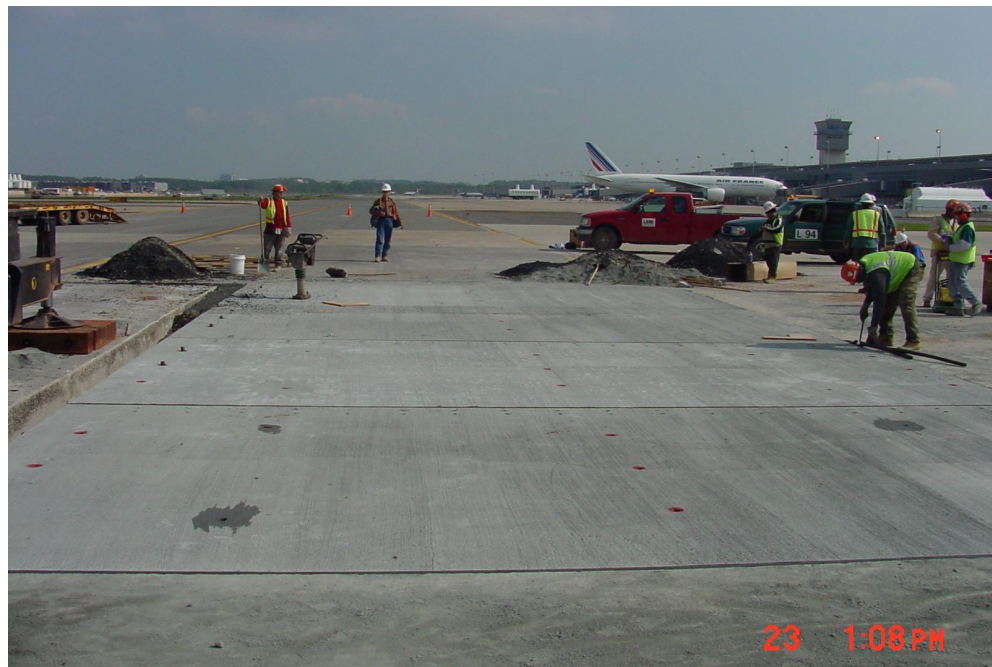
Figure 46 - Dulles Taxiway Bravo PCP Completion
(Fischer, 2002)

construction team. The two subsequent Bravo panels were completed in nine and a half hours and the two Taxiway Yankee panels were completed in eight and a half hours. This shows the steep learning curve of the new technologies and contractors not familiar with the process. It also shows the importance of a test run to work out the personnel and equipment allocations. The slab demolition and finish grading required substantial time. Currently, the technology and processes have improved over the past 15 years and are more efficient and familiar to contractors. For highways, production rates are as high as 475 – 600 yd² per eight-hour closure (Smith P. , 2015). Due to the larger size PCP for airports, larger equipment must be used to remove, haul away and install new slabs as seen in Figure 45. Also, consideration should be given to the distresses present in the slabs. Instead of lifting out in a monolithic piece, multiple pieces may need to be considered (Figure 45). Lifting anchor placement may vary. If the slab is shattered, other demolition equipment will be required to remove the pieces while limiting subgrade disturbance. Figure 46 shows the finished installation after the first night in 2002. This project, after the learning curve, met the project expectations as an acceptable rapid repair technique. While the initial design was for five to ten years, the pavement is still performing well after 13 years. Figure 47 shows the current in-service condition in 2015. A small corner patch is visible in one of the slabs. Small, tight cracks are seen but are not concerning as they are held together by the steel reinforcement.

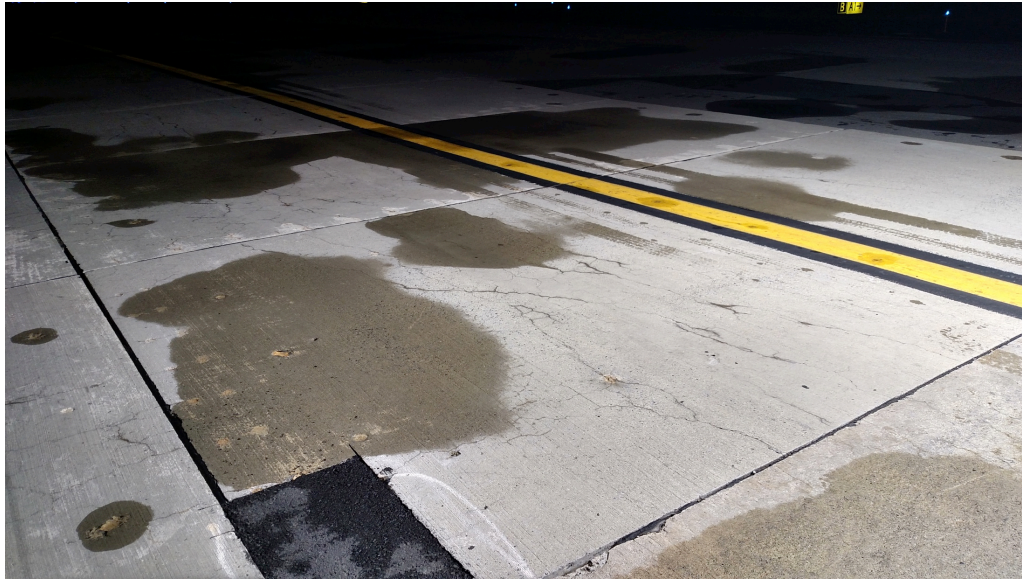
Figure 47 - Dulles Taxilane Bravo PCP Condition
(Thurma, 2015)

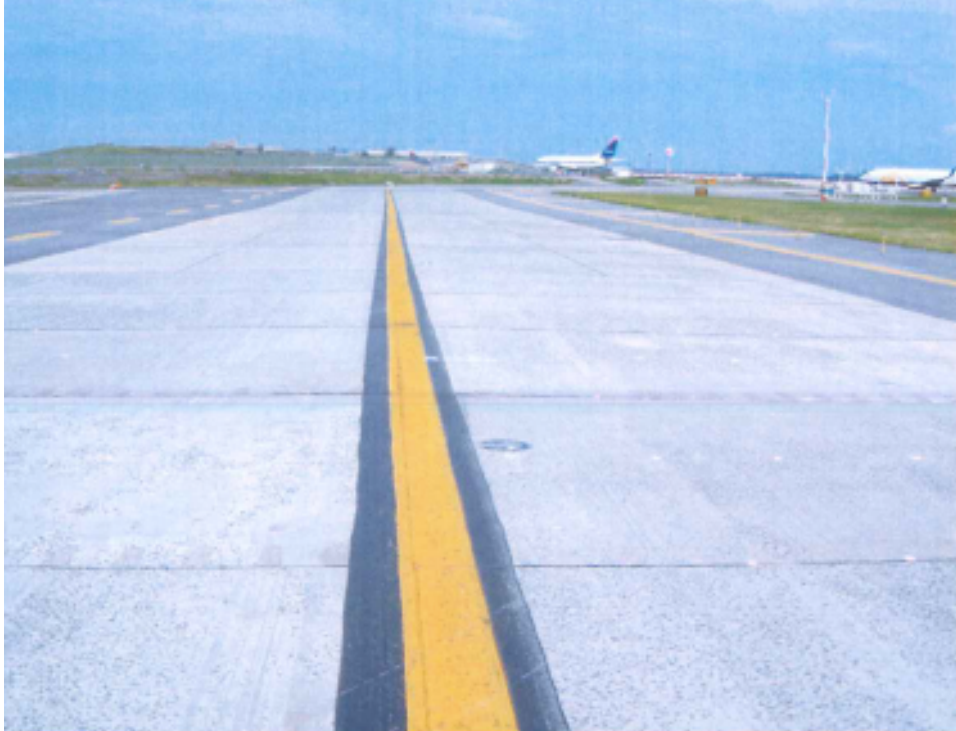
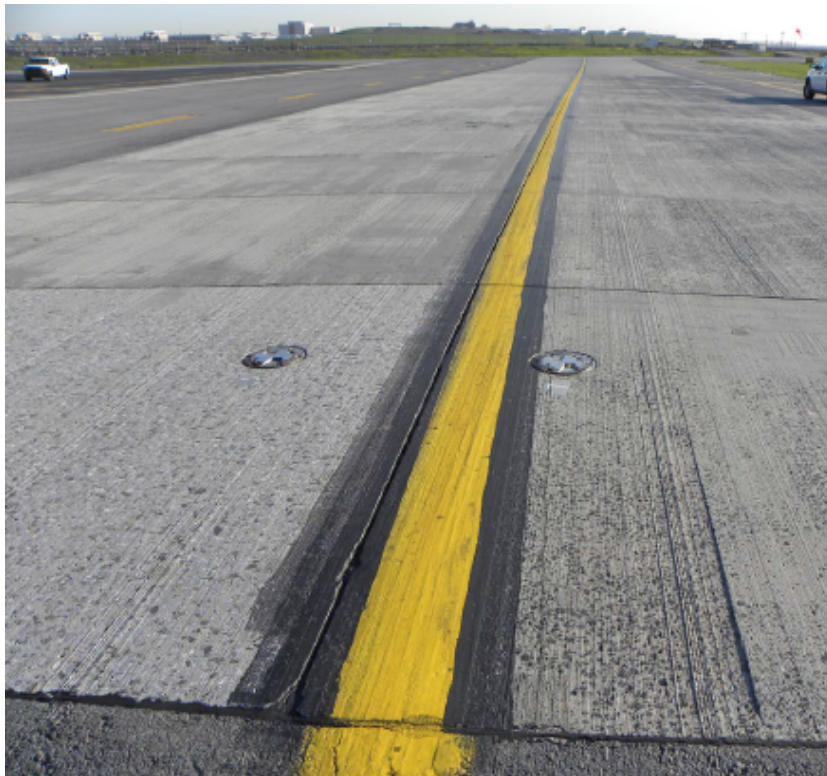
Figure 54 - La Guardia PCP

a) Post construction

b) Condition in 2010

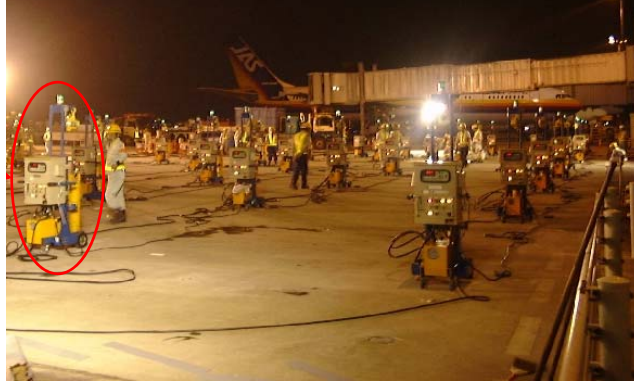
Figure 56 - Japanese Lift-up Method Jacks in the Field
(Tsubokawa Y. , 2015)

The Japanese Ministry of Land, Infrastructure, Transport and Tourism have used various forms of precast panel systems since 1965 with great success. The use in airports began in 1970. Japan's PCP use (total area) in airports alone, dwarfs the United States' use in highway and airports combined. Since 1970, Japan has installed 22,645,322 ft² (2,103,822 m²) of PCP at airport installations (Table 27 in the Appendix). Their use has been on every airfield feature and was used for maintenance, rehabilitation and new construction lasting more than 20 years. The most common reasons for using PCP in Japan is the inability to close the facility or when large settlements are forecasted (Tsubokawa, 2015). Costs are approximately \$770/yd² (\$540/yd² with a 30% area cost factor), which is higher than CIP without the multi-day closure to aircraft. They have primarily used three methods, post-tensioning systems, traditional precast methods with varying joint connection types, and a slab lift-up method (leveling/lift rods in the slab). The lift-up method is unique and is used to raise PCP slabs after settlement. Figure 55 shows the coring, reaction bed, jack assembly, slab lift-up and grouting procedure for this method. Figure 56 shows the field performance of the jacks, which are controlled by a computer. A fourth method, 'Precast Reinforced Concrete Pavement (PRC)', has recently been developed. This is a heavily reinforced slab using a lattice truss for reinforcement (flexural strength 928 psi). The load transfer mechanism is a cotter joint. A typical cross-section is seen in Figure 57 and Figure 58 shows the lattice truss and the cotter joint. This pavement is used in locations on airports and in port facilities with very heavy loads.

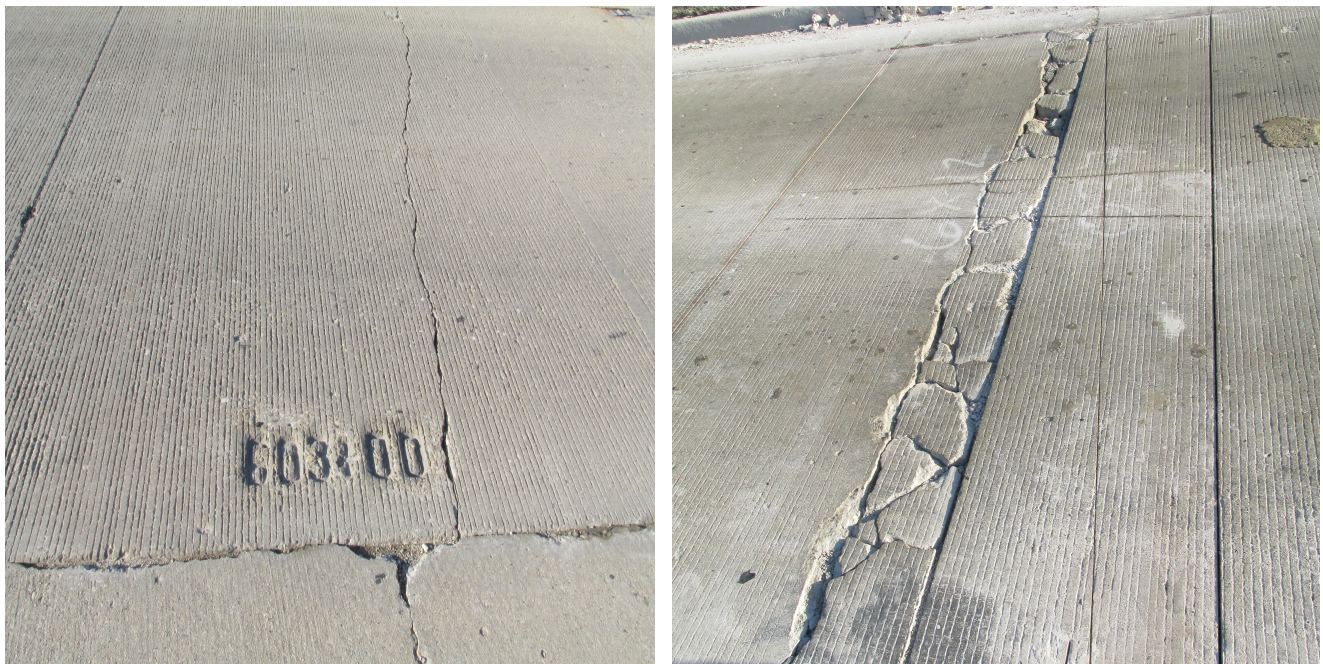
Figure 59 - Typical Distress on Illinois Route 62
(Kulikowski, 2015)

A site visit was conducted on 15 September 2015 in South Barrington, Illinois along a 1-mile stretch of Route 62 (Algonquin Road). The Illinois Department of Transportation used precast panel rehabilitation to repair both consecutive and intermittent locations over a 3.5-mile section on the two westbound lanes constructed in August 2000. Similar repairs were accomplished in the two eastbound lanes the previous year. The existing slabs were 12 ft by 15 ft x 12 in thick. The narrow mouth surface slot with drilled/epoxied dowel design was used for the load transfer between slabs. The project value was \$1.17M and replaced 125 – 6 ft x 12ft x 12 in slabs. R.W. Dunteman was the prime contractor with J.A.C.K Coffey LLC performing the demolition work. This site visit was conducted to become familiar with the process, manpower, and equipment. Based on a visual assessment, the primary of distress was transverse cracking various degrees of joint/crack spalling were also seen (Figure 59).

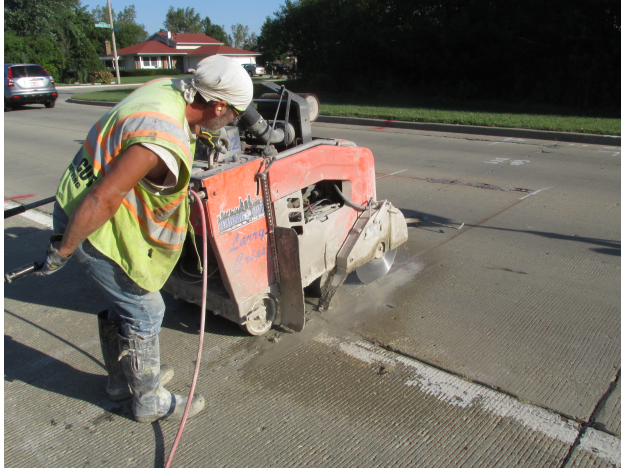
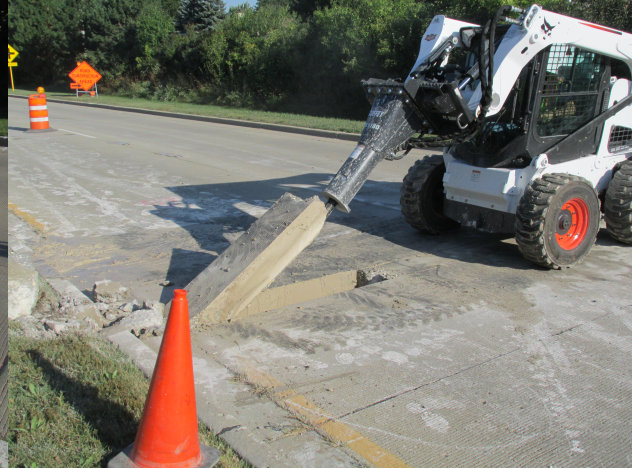
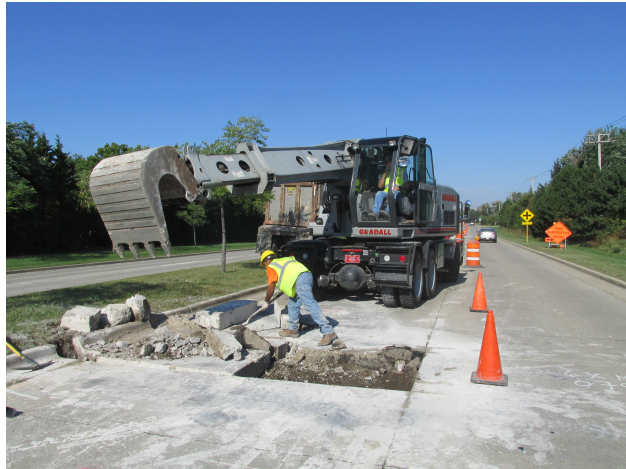
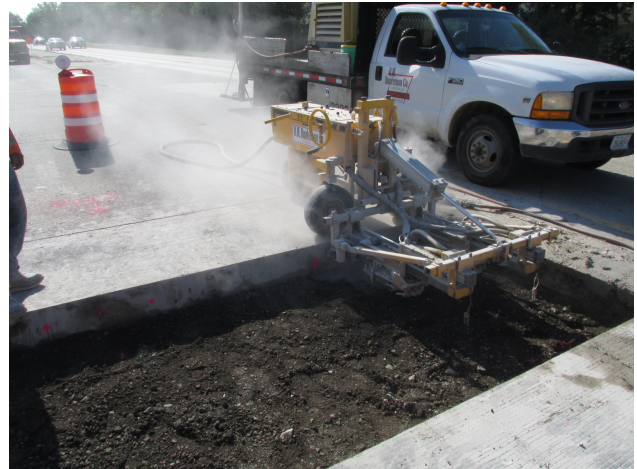
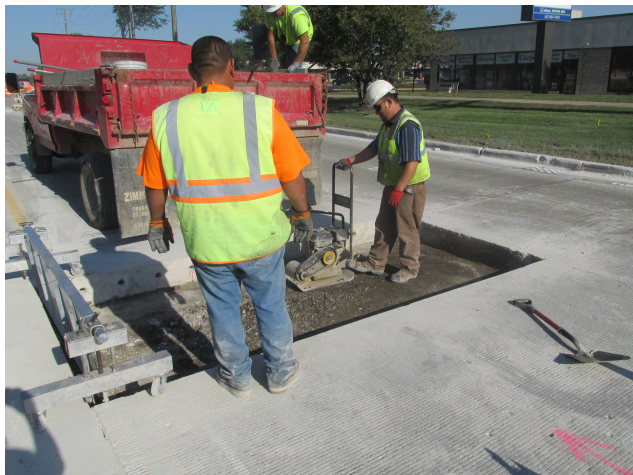
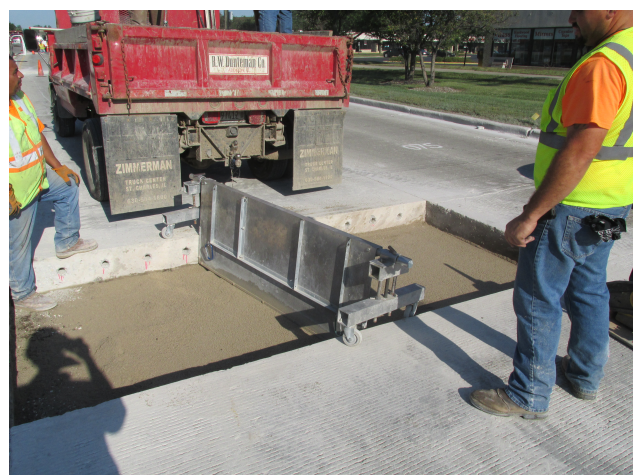
Figure 60 - Route 62 PCP Installation Process
(Kulikowski, 2015)

a) Saw cutting

b) Initial demolition

c) Slab removal

d) Dowel bar drilling

e) Subgrade preparation/bedding material

letters in Figure 60). These times do not reflect the learning curve involved if the contractor is not familiar with precast work. The contractor averaged about 12 – 15 slabs per day. Figure 60 shows the construction photographs for each of the activities in Table 14. Saw cutting requires multiple passes to maintain a vertical face. If care is not taken to maintain a vertical face, the slab removal (wedged in) and installation (no contact with subgrade) will have problems and the contractor will have spend extra time to correct the deviation. The problem can be greater on deeper slabs such as those used in airports. For slab removal, a gradall machine was used instead of the lift out method. Its use was more economical based on slab size and efficiency. Some subgrade disturbance occurred but was less than typically seen for breakup and removal methods. The disturbance was re-compacted with a small compactor and an angular fine aggregate material was place over the subgrade to bring it to proper grade. Demolition and subgrade preparation accounted for 52% of construction time with the remaining going to the installation. The actual placement of the slab was less than 1% of the total construction time. The short placement time coupled with the narrow mouth surface slot allows flexibility to open to traffic expeditiously in the event of an emergency. Precast panels have been used as temporary and temporary-to-permanent (grouted one day or more later) repairs in both highways and airports (Crawford, Murphy and Tilly, Inc., 2000; Fischer, 2002; Rao, Mallela, & Littleton, 2012). Designing a tool to insert multiple dowels into drilled holes or adding more manpower would save substantial time in the overall process as it accounts for 17% of the total time.

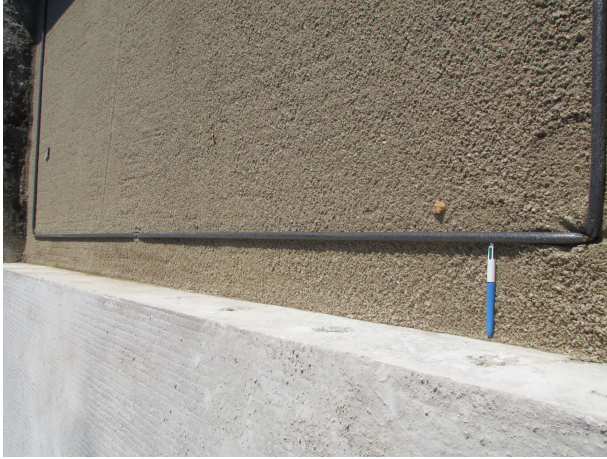
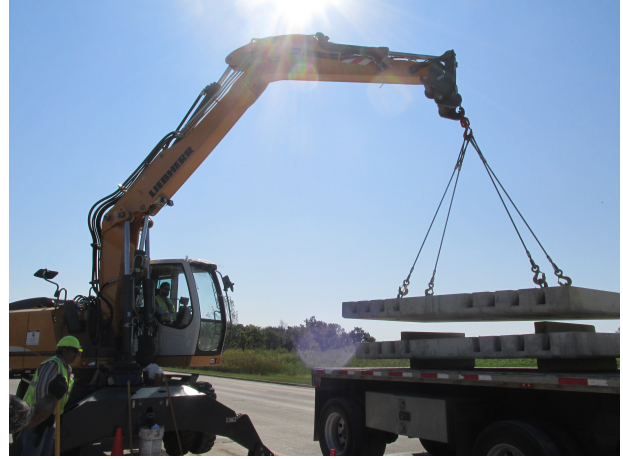
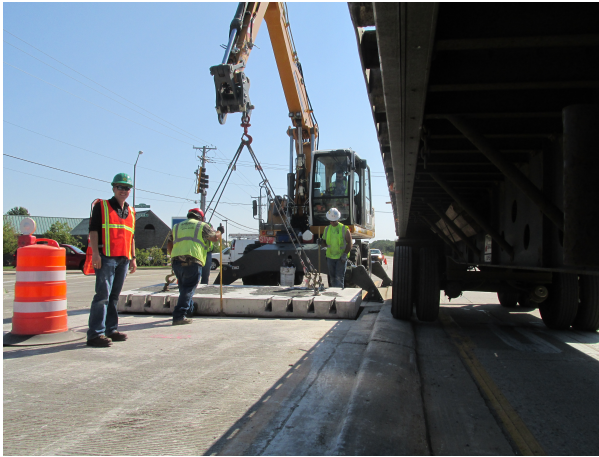
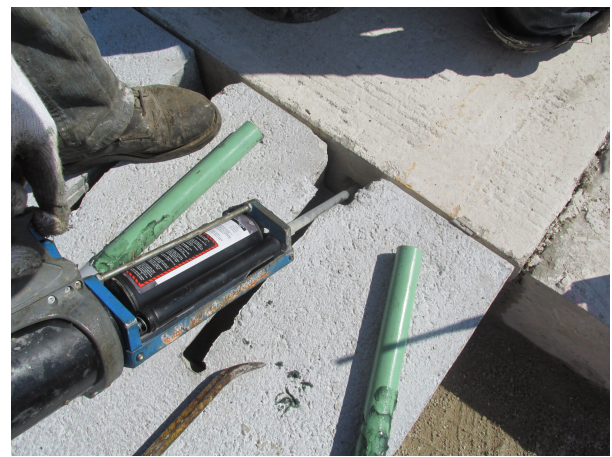
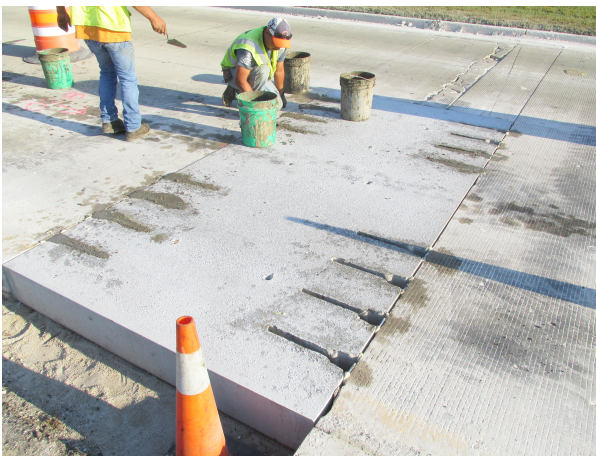
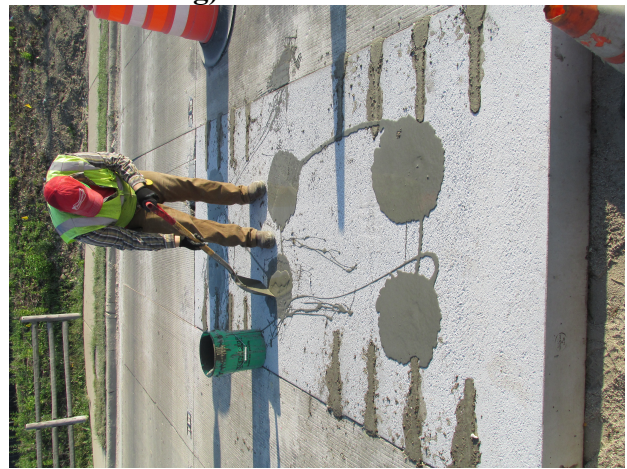
Figure 60 (cont.)

e) Subgrade preparation (grout seal)

f) PCP install

g) Dowel bar insertion

h) Top grouting of dowel bars

i) Underslab grouting

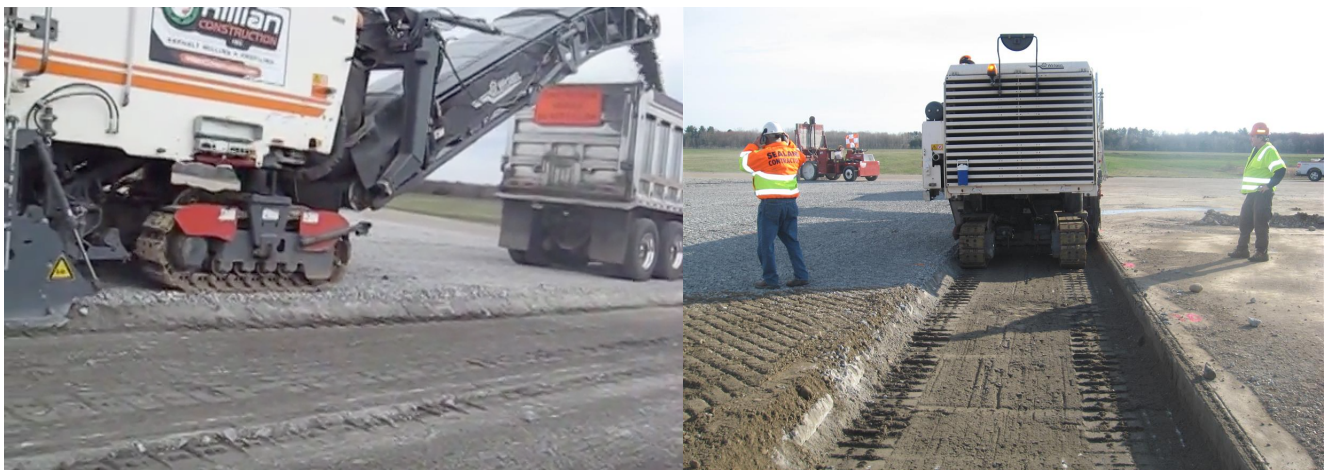
Figure 64 - Milling of Rubblized PCC Runway at Griffiss International Airport
(Antigo Construction, 2013)

and required constant specialized maintenance. Subsequently, the two-phase breaking process was implemented to increase productivity (Rudolf, 2015). Additionally, elevation restrictions require maintaining existing profiles and thus milling the rubblized PCC must be considered. This technique was first conducted in 2013 at Griffiss International Airport on TWs A, C, D and K, in Rome, NY, which included a five-inch AC overlay. The original PCC thickness was 16 – 24 inches. The rubblization prior to milling accelerated the cold milling process, decreased machine wear and was deemed successful for the contractors and the airport (Shinners, 2015). Figure 64 shows the milling process.

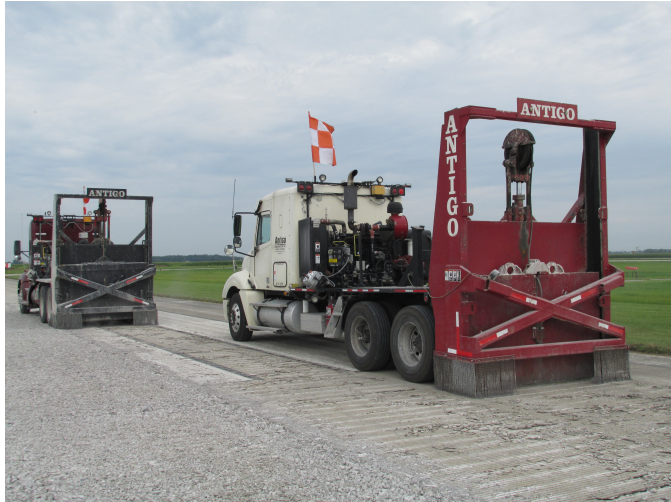
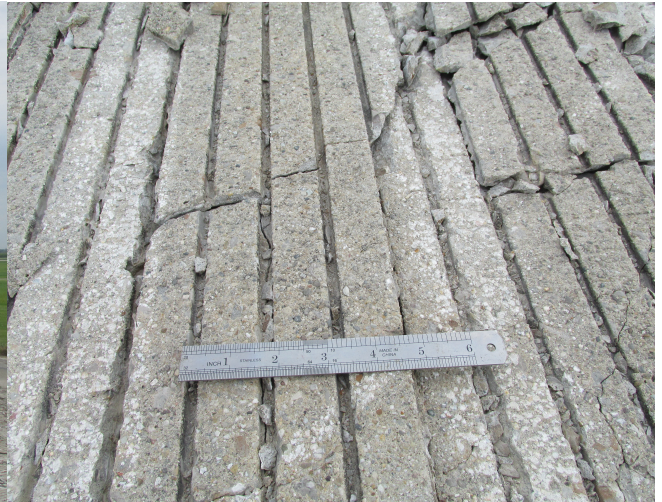
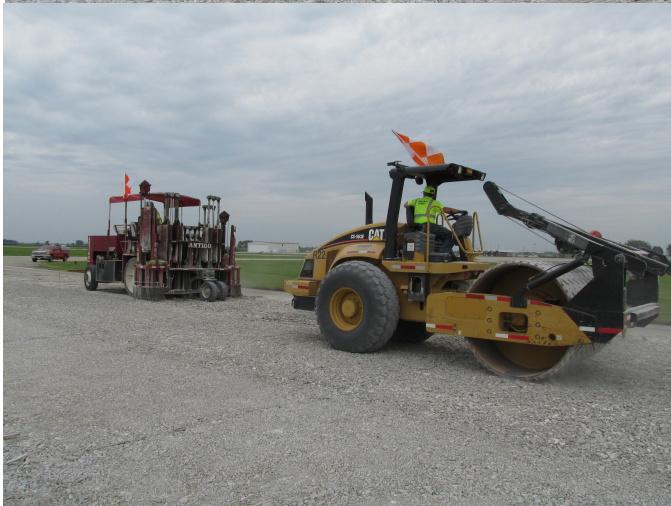
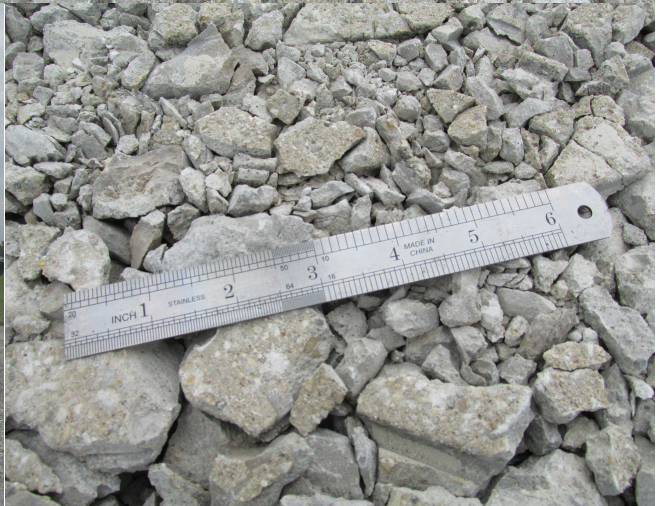
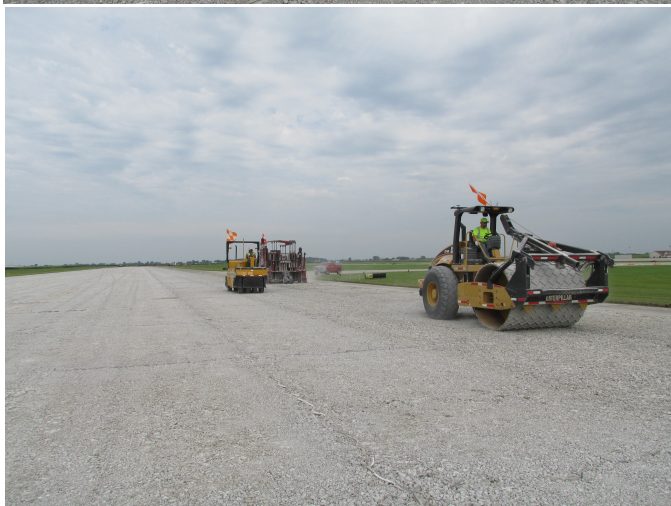
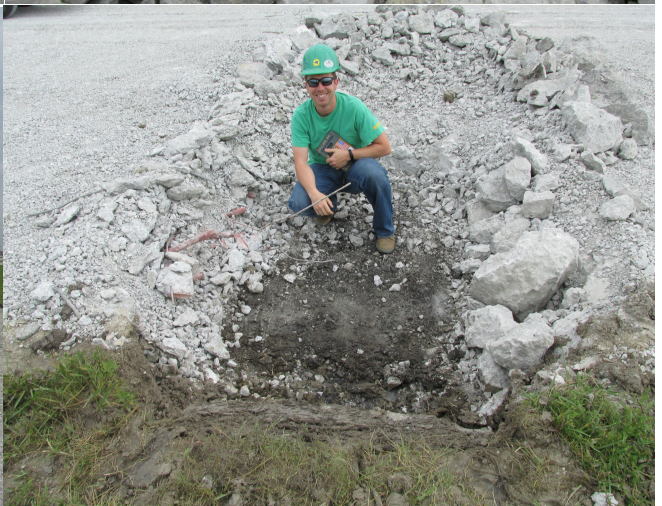
Figure 65 - Rubblization at Coles County Airport - Charleston, IL
(Kulikowski, 2015)

More recently a rubblization with a mill/inlay with an AC overlay was conducted in July/August 2015 at Coles County Airport in Charleston, IL. The rubblized PCC was 14 inches over a 7-inch bituminous base layer. The constructed AC overlay was a minimum of four inches thick, with an average of five and a half as found by ground penetrating radar. The project called for milling in various locations to meet elevations of connecting taxiways. To accelerate the process and eliminate reflective cracking the project was modified and rubblization/milling was allowed. Figure 65 shows the guillotine breaker (dropped every 8-12 inches), the multi-head breaker and z-grid roller. The final product after each step is also seen. The test pit shows the effectiveness of the two-step breaking process. Figure 66 shows the milling and the subsequent overlay using a stringless paver. No issues were reported by the contractor and airport owner with this design and construction process.
